## SERVICE BULLETIN

#0017

**SUBJECT:** Potential risk of shearing of control stop plate rivets

**MODELS AFFECTED:** Sling 4 and Sling 4 TSi aircraft

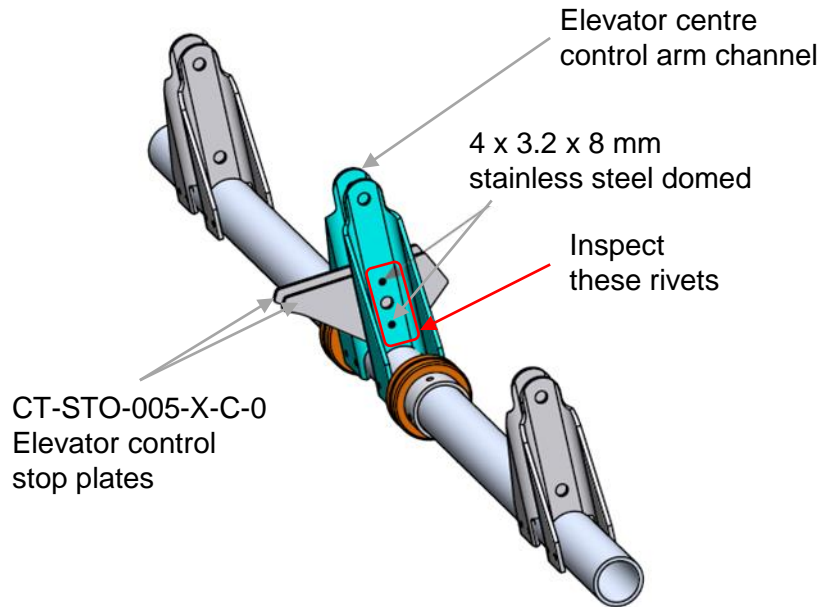
Figure 1 - Elevator control torque tube for Sling 4 and Sling 4 TSi aircraft

The Service Bulletin provides the instructions for the inspection, and if required repair, of the elevator control torque tube for Sling 4 and Sling 4 TSi aircraft. Internal quality checks have shown that elevator control stop plates in some aircraft may have been installed with aluminium 3.2 x 8 mm domed rivets instead of stainless steel 3.2 x 8 mm domed rivets. These aluminium rivets shear at lower control stick loads compared to the stainless-steel rivets, so it must be ensured that stainless steel rivets are installed.

1. The rivets on the torque tube that need to be inspected are shown in Figure 1. The control stop plates (CT-STO-005-X-C-0) and elevator centre control arm channels are also shown in Figure 1.
2. Remove a front seat from the fuselage then use the 2 mm / 2.5 mm Allen key to remove the floor skin (refer to CF-SKN-016-R-C-0) shown in Figure 2.
3. The inspection region when the floor skin is removed is shown in Figure 3. Use the light source to determine if control stop rivets are aluminium or stainless steel. Use Figure 4 as a guide for making the distinction.
4. Alternatively (or in addition to using the light source) use a magnet to identify rivets. The mandrel of the aluminium rivet used is magnetic, so a magnet will attract to the aluminium rivet (see Figure 4).

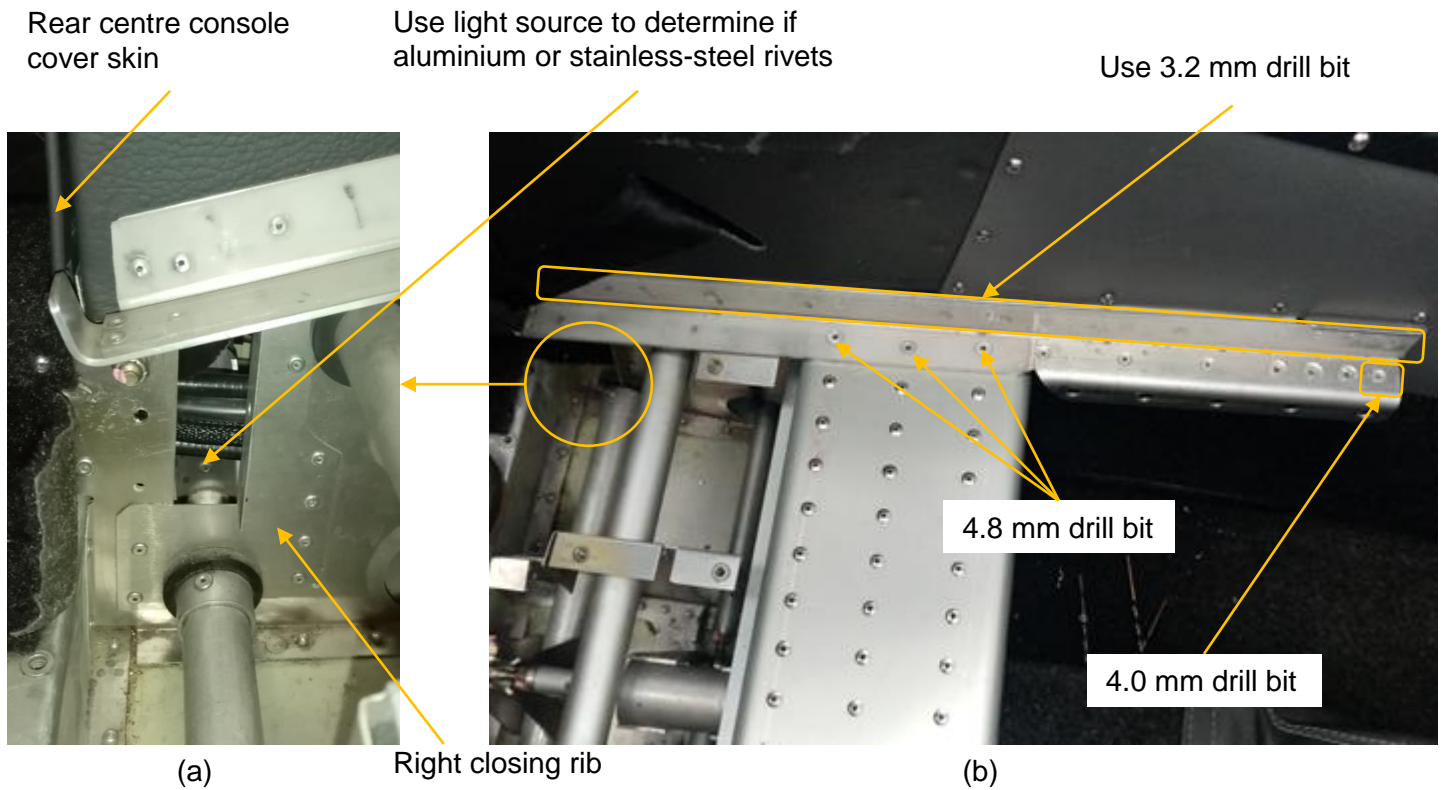
Figure 3 - Region of inspection area and seat rail

11. Cut the cable ties that guide the centre console wiring and pitot static tubes (using the side cutter) to reduce their tautness, then use the angle drill and 3.2 mm drill bit to drill heads off the rivets on the closing rib as shown in Figure 5(b). The closing rib on the centre console RH side is shown in Figure 3(a).

7. Drill the heads off the countersunk rivets shown in Figure 3(b) with the angle drill (using 3.2 and 4.8 mm drill bits) to remove seat rails.
8. Remove and retain all M3 / M4 screws on the aft section of the centre console to separate it from the forward section as shown in Figure 5(a).

17. The AN4 lock-nuts (hardware designation AN365-428A) must be tightened such that the seat belt brackets can still swivel.
18. Install the controls closing ribs (CF-RIB-009-R/L-C-0 shown in Figure 3(a)) using the 3.2 mm clecos to align the holes. Assemble with (20) 3.2 x 8 mm aluminium domed rivets.

20. Return the seat rails, including the plastic plates, using clecos to align the holes before riveting. Use the hand riveter, two 4.0 x 10 mm and six 4.8 x 15 mm countersunk aluminium rivets to assemble the seat rails. In addition, install the (18) 3.2 x 10 countersunk aluminium rivets on the upper rails (see Figure 3(b)).
21. Return the rear centre console cover skin and the floor skin shown in Figure 3(a).
22. Any dome head cap screws experiencing resistance during assembly should be cleaned with an M3 / M4 thread tap (tap size depending on year model).

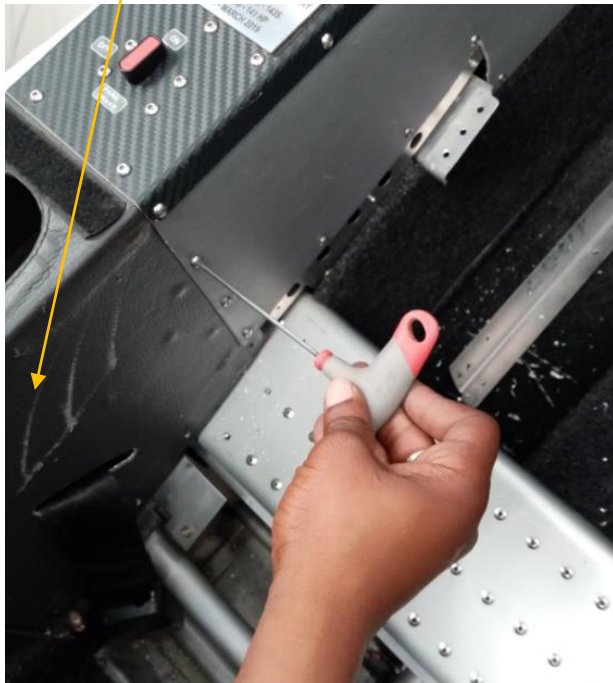
(a)

Separate aft  
section of  
centre console

Forward  
section of  
centre console

19. Return the aft section of the centre console using the 2 mm / 2.5 mm Allen key and install the M3 / M4 screws (see Figure 5(a) which shows disassembly).

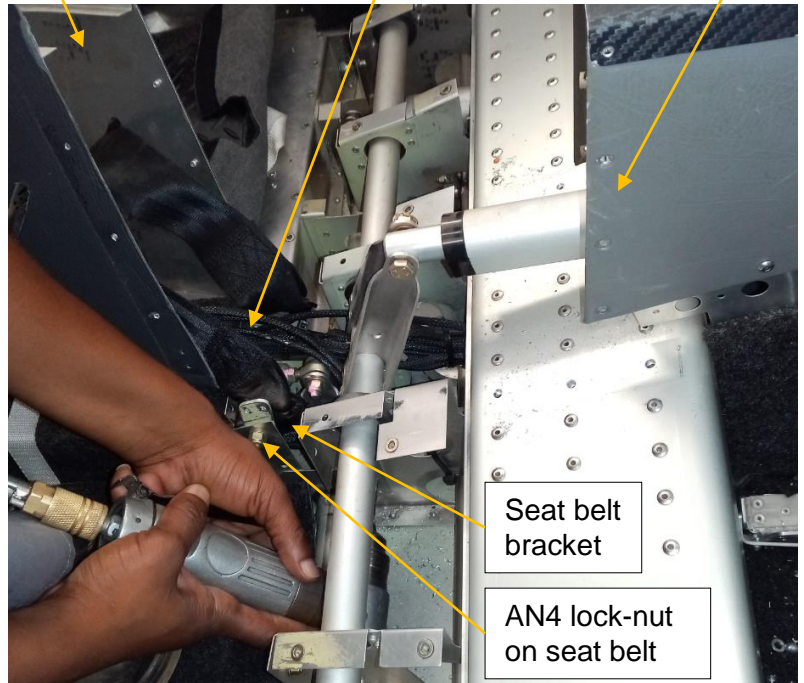
(b)

Aft section of centre  
console pulled away

Cables/wiring/pitot  
static lines running  
through centre  
console

9. The aft section of the centre console must be carefully pulled away so as not to damage wiring and pitot static lines running through the console as shown in Figure 5(b). If resistance is felt separating the aft and forward centre console sections, the headset jacks should to be removed with the 14 mm spanner and socket. Be sure to label these cables left and right so that they are refitted in their original positions (see Figure 6).

12. Use the 7/16" spanners to loosen the AN4 lock-nuts (hardware designation AN365-428A) on seat belt shown in Figure 5(b) so that the seat belt bracket can swivel. This will ensure there is sufficient room for the hand riveter to be pressed firmly against elevators' centre control arm channel when installing the 3.2 x 8 mm stainless steel rivets (See Figure 7).

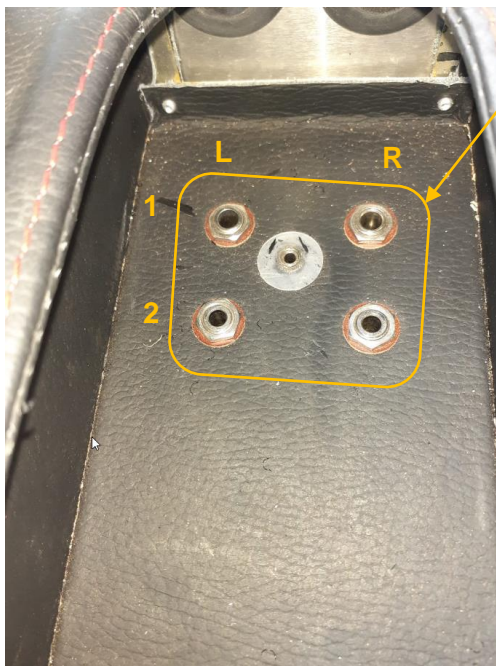
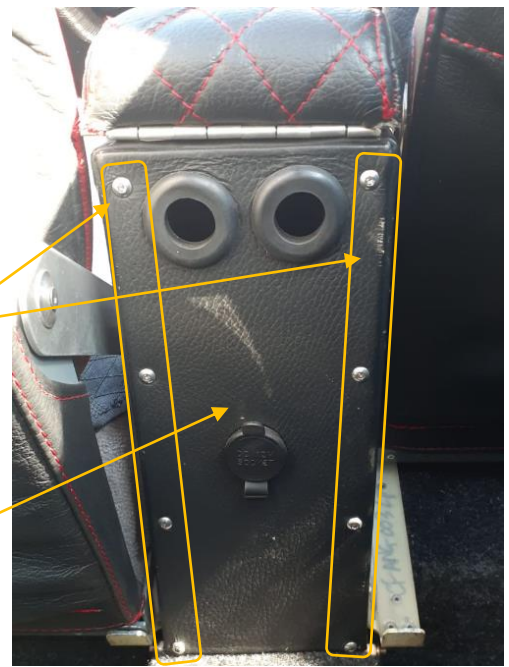
Figure 6 - Remove headset jack nuts

Remove with M14  
spanner and  
socket

Remove these  
with 2 mm /  
2.5 mm Allen  
key to access  
underside of  
jacks

Rear centre  
console  
cover skin
